POTOMAC RIVER BASIN

Name Of Dam: SOUTH RIVER NO. 10A

PHASE I INSPECTION REPORT

NATIONAL DAM SAFETY PROGRAM

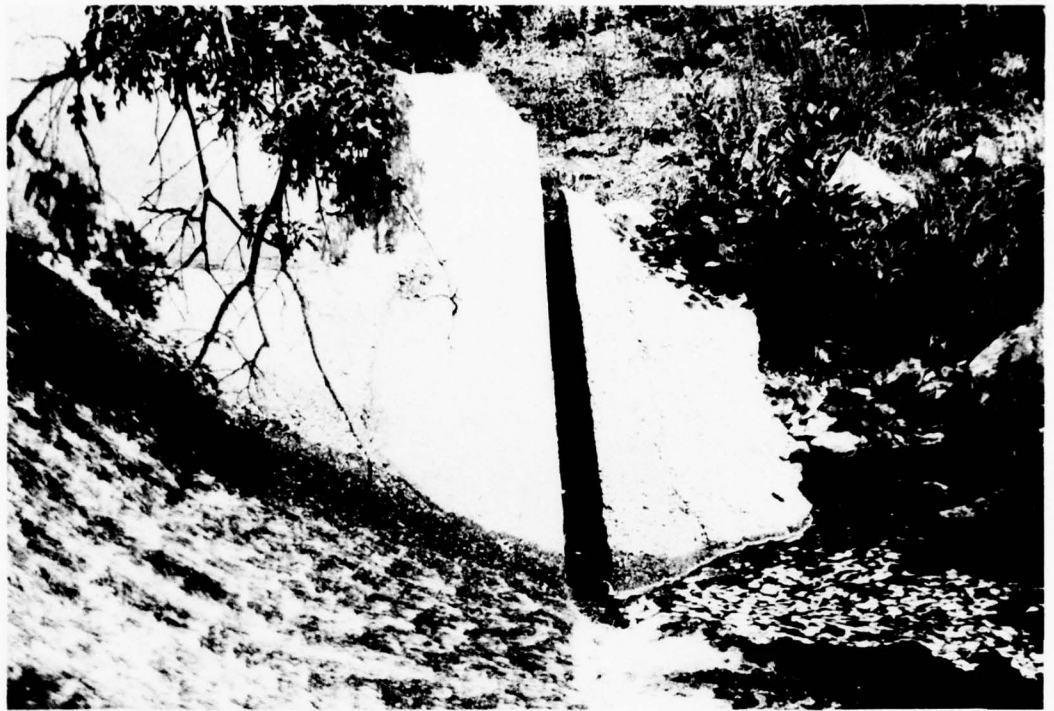
3.1.3 Appurtenant Structures: The water supply intake (currently not in use) located at the outlet of the principal spillway conduit has some erosion beneath its downstream end. This has caused the concrete slab on the left side to drop and separate about eight inches at a construction joint (see Photo 1).

PHOTO 1. Spillway and Wing Wall of Outlet Structure

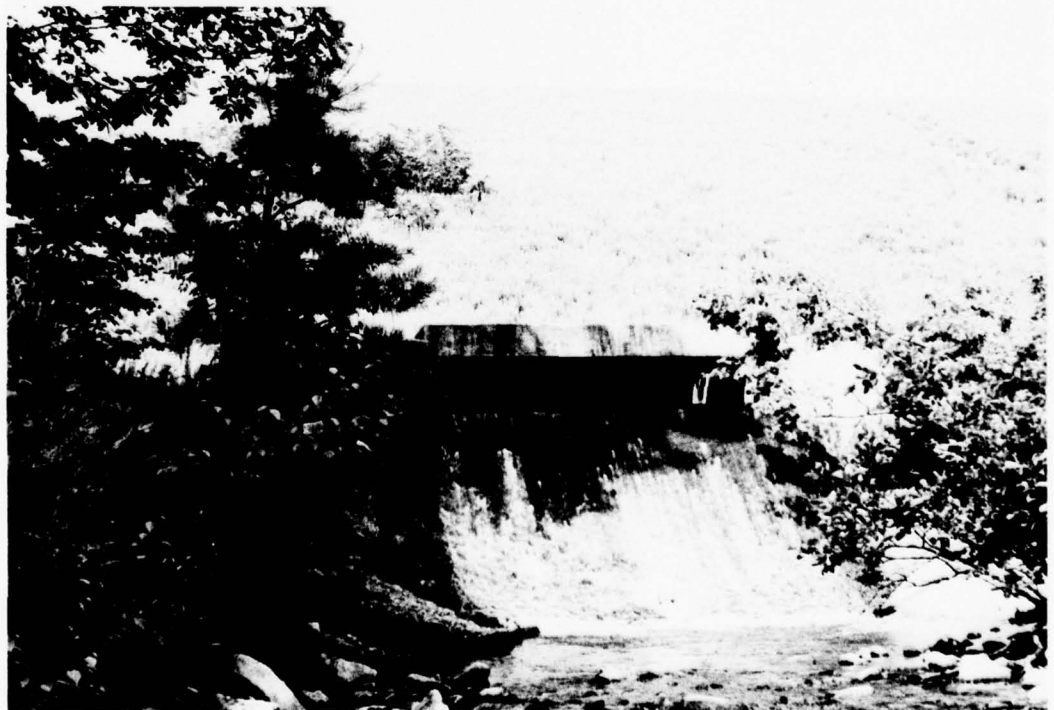
PHOTO 2. View of Outlet Structure Below the Embankment

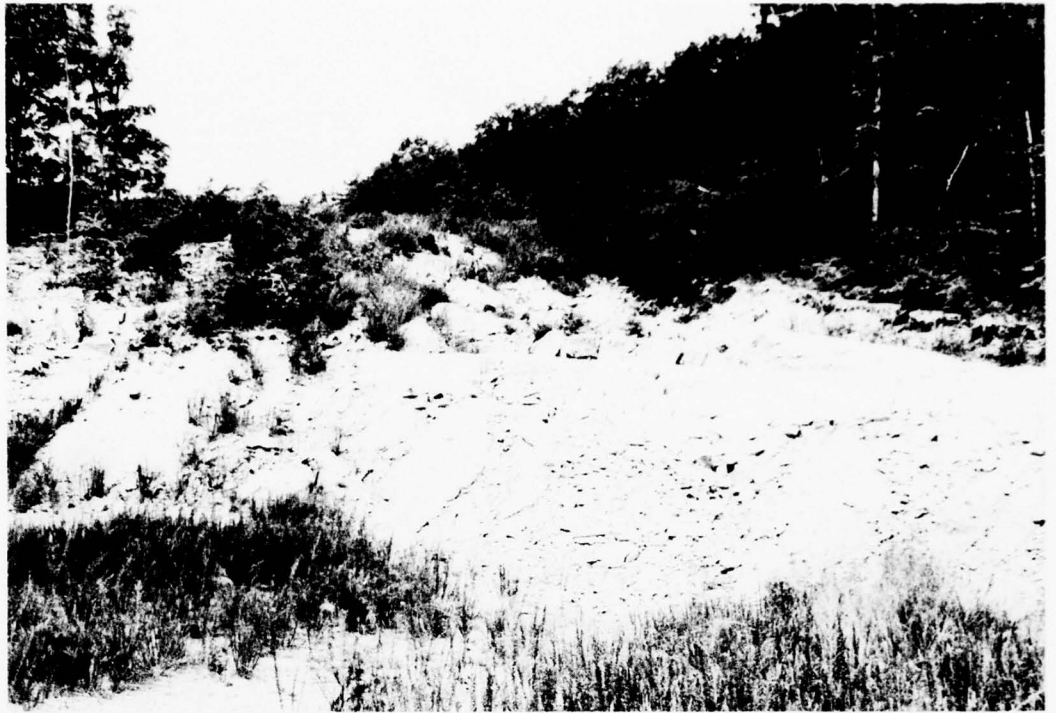
**Photo 3. Looking Upstream Towards Drop Off at Downstream
End of Emergency Spillway**

DISCHARGE CHANNEL	Sandstone bedrock was exposed at the downstream end of the discharge channel. The discharge channel appears to have been severely eroded.	The area of the earth excavation should be repaired and seeded.
-------------------	---	---

- 7.2.2 Other Recommendations: Repair of the eroded areas on the upstream and downstream slopes of the dam, and the channel downstream of the emergency spillway will be necessary. The erosion channel at the downstream side of the embankment - left abutment contact should be filled in and seeded. All small trees growing on the embankment should be removed. The vegetation covering the rock toe should also be removed. Riprap should be placed in the stilling basin to the level of the concrete toe to prevent further erosion in this area. The handwheels for slide gates 2 and 3 should be removed or securely fastened to prevent their unauthorized use. The heavy brush growing on the banks of the outlet channel should be cleared periodically. These items can be accomplished through the annual maintenance program. It is also recommended that the grass on the embankment and abutment be cut before the annual maintenance inspection. Stability analyses should be performed on the upstream slope assuming full drawdown conditions.

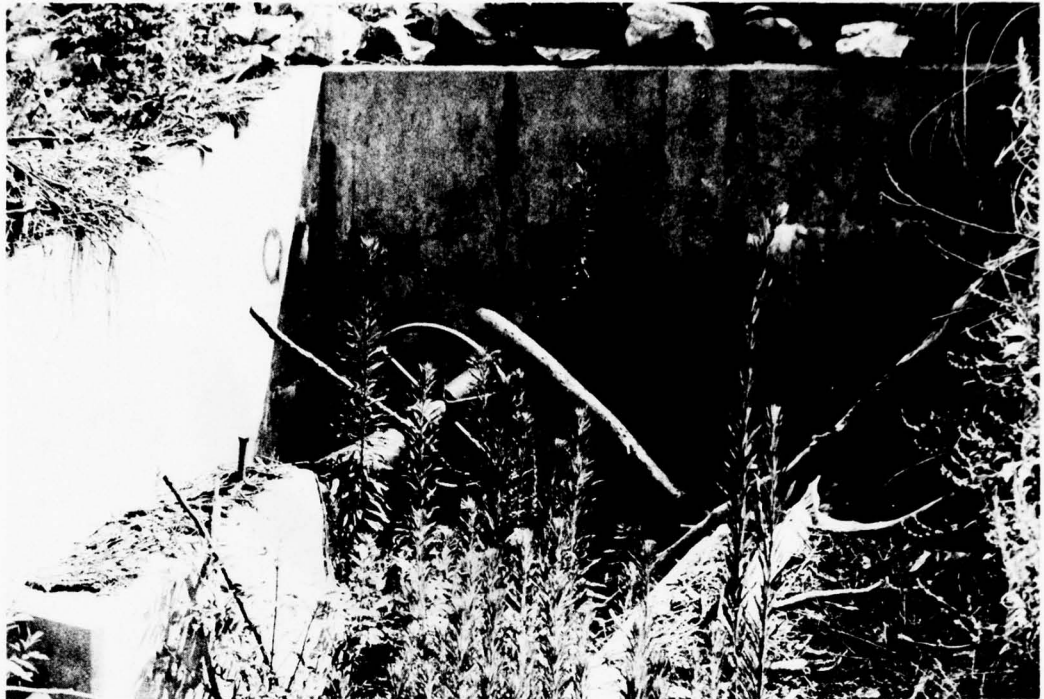
PHOTO 5. Pit for Operational Valves at Base of Front Face of Embankment

EMERGENCY GATE	There are four hand-operated intake gates (one below normal pool, one on the riser, and two on the upstream face of the dam). Control wheel on riser was broken off, and one of the wheels in the valve pit was unlocked.	Remove or lock control wheels.

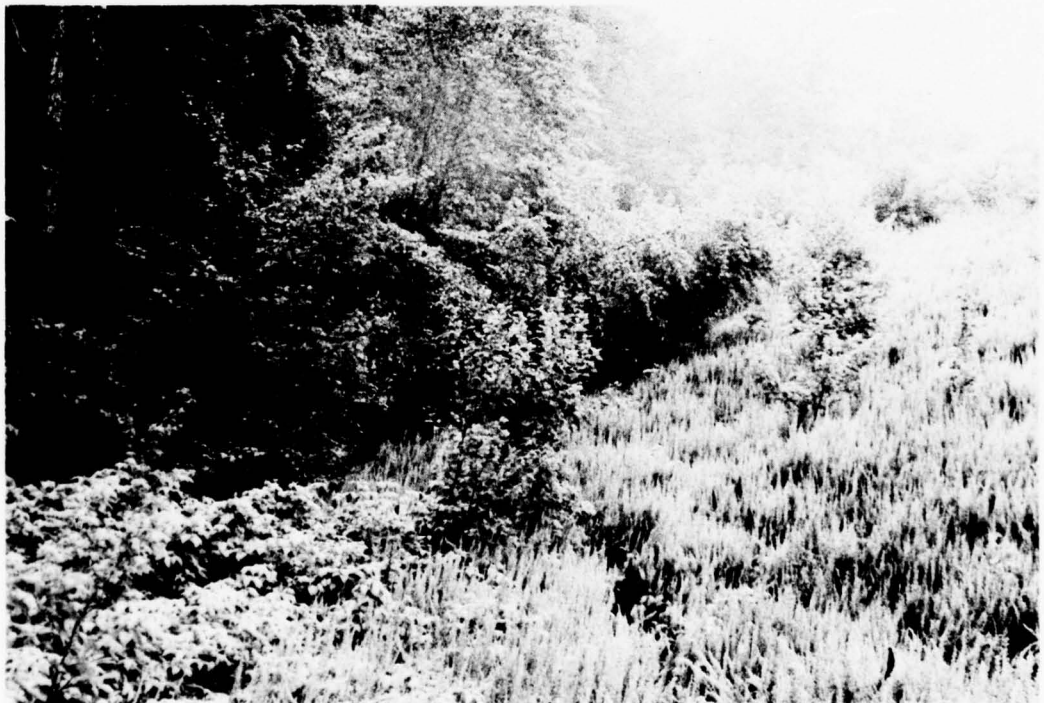
**PHOTO 6. Brush and Trees on Downstream Embankment Near
Intersection With Right Abutment**

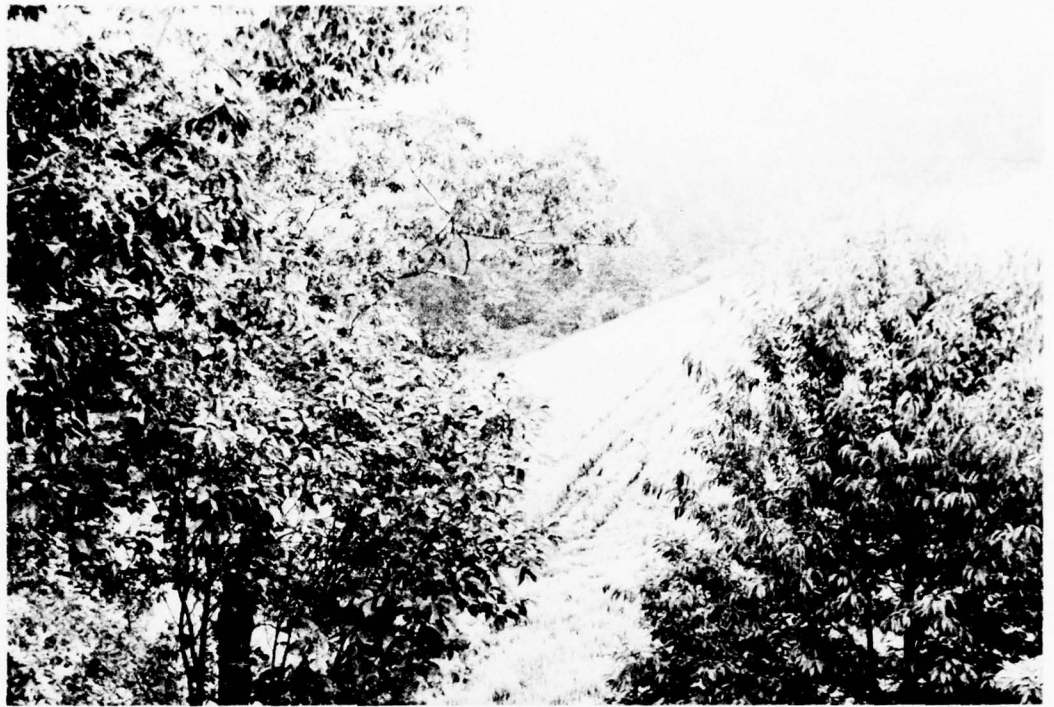
PHOTO 7. Ruts Made by Vehicles on Bench Area
